Nissan : Armada (Including Pathfinder Armada) :
2006-15 : 4X2 : except Self-leveling Suspension

Wheel Alignment

Nissan 2017 Frontier 4X4

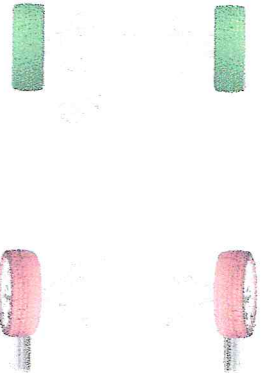
FAILED

- Front Total Toe
- Front Camber
- Rear Total Toe
- Rear Camber

Recommend an all wheel alignment for added tire life, fuel economy and safety.

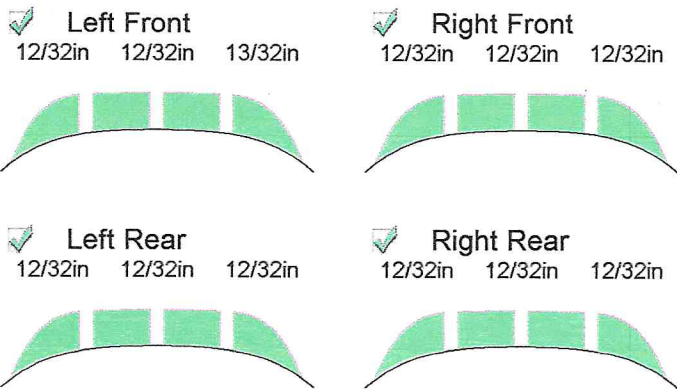
Tire Health

PASSED

Recommend a Tire Rotation for Even Tire Wear
